EVO – lighting test

Problem: The feet are not visible in the live view. In the software a message that “No Feet detected” could appear.

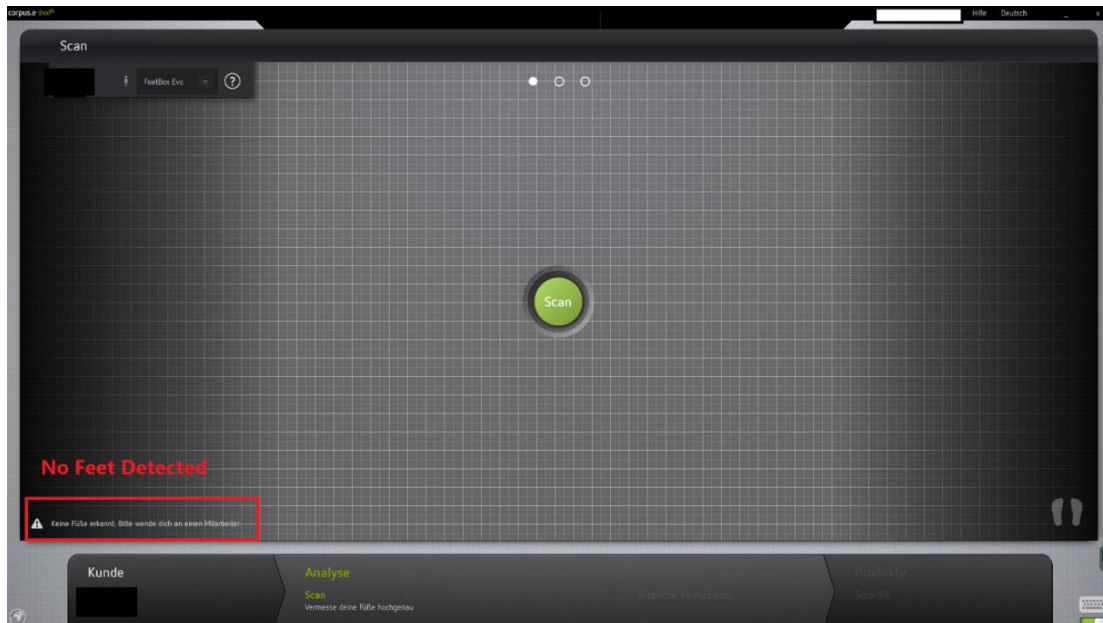
Description: This case usually occurs if the requirements for a scan or successful measurement is not given, the example picture shows flickering and artifacts on the display. This is not necessarily an indicator for a hardware or software defect, to rule out such check points listed here:

To rule out last point, please perform following **test**:

- Turn off any ceiling lighting
- Close all blinds close to the device
- Darken all windows / light shafts temporarily close by
- Cover / block all light sources from the side e.g. with a carton or similar

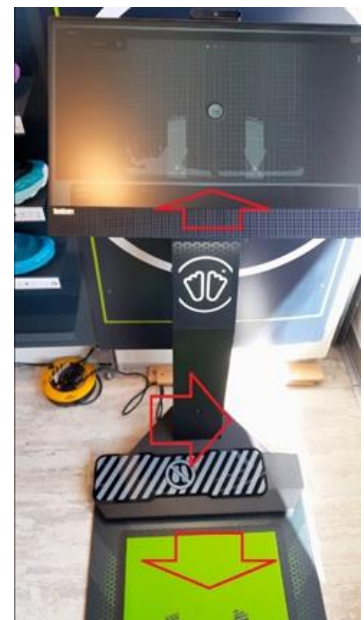
- This is not connected to a camera or hardware problem
- This occurs when the visible green area allows no valid measurement
- Most frequent causes are:
 - No person on the scanner
 - Left or right foot not correctly positioned/centered
 - Shadows /artifacts from external light sources (sun, spotlight...)
